Application Solutions

Packaging Industry

Inspect Labels on Opposite Sides of a Shrink-Wrapped Bottle Multi-Pack

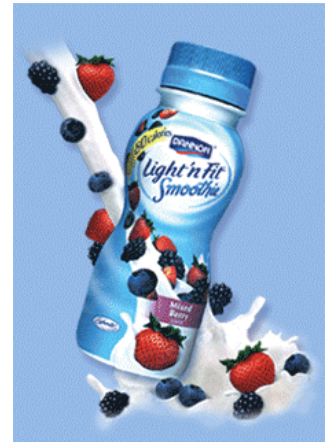
Dean's Foods, a dairy products packaging company, bottles drinkable yogurt under license for Dannon Foods. The final packaging is a shrink-wrapped carton containing 12 bottles. Labels are applied on opposite sides of the carton as it moves down a conveyor to palletizing. Dean's Foods needed to demonstrate 100% verification of label placement to Dannon to maintain the licensed business. Improperly labeled cartons that enter the supply chain get lost in distribution centers, may never reach the retail floor, and ultimately remain unsold, turning into a loss for the packager. The shrink-wrapping made label detection unreliable using conventional background suppression sensors.

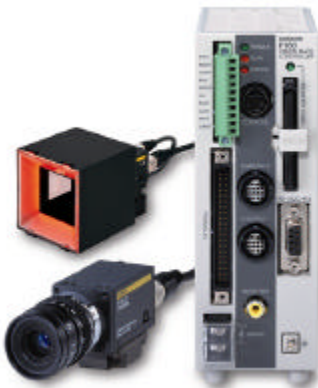
To get reliable detection of labels applied to the shrink-wrapped carton, Omron's F160 vision sensor and two cameras were proposed as the solution. Its preprogrammed Label Tool function simplifies setup to verify label placement. A trigger sensor synchronizes the inspections. After a lab test to verify proof-of-concept, Dean's Foods tested a demo stand containing an F160 vision sensor, a power supply and trigger sensor for two-weeks on their production line. With the test satisfactorily completed, Dannon was advised of the results. The system was installed and Dannon reimbursed Dean's Foods for the system costs.
