## Application Solutions

### Packaging Industry

#### ***Molded bottle opening inspection detects molding defects.***

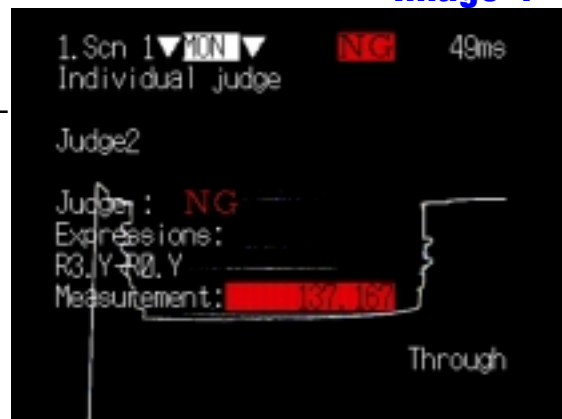
**Image 1**

Multiple edge detections are performed at critical locations to determine molding errors as shown in image 1 at right. Image 2 and 3 show the mathematical calculations to determine if tolerances meet specifications.

By using the F160's edge extraction filter, edges can be highlighted for easy detection and measurement using edge detection software tools. With the use of a backlight, edges can be highlighted and extracted with ease. By using the F160's judgment calculation capability, edges with tolerance relationships can be manipulated against each other to determine width and height measurements and compensate for movement of the bottle in the field of view.
